The 6<sup>th</sup> International Conference on Mining Science & Technology

## Study on the layer spalling of the KMPS546 speed reducer input conical

Li Ai-Min\*, Chen Fei

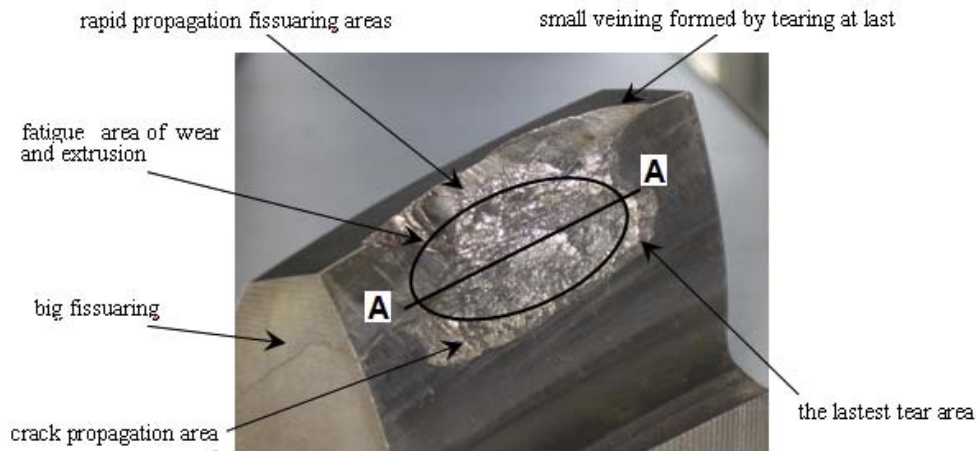
The largest spalling was shown in figure 1. The length and width of spalling area were about 5.5 mm and 4 mm, respectively. The spalling area could be divided into two parts, which were shown in the A-A line of figure 1. After removing the gear tooth by longitude line cutting and washing, a clear macro-crack could be found inside the gear tooth. The crack was long and thin and it also contained curves. The crack almost spread through the whole thickness of the gear tooth.

The whole spalling area could be divided into two portions. The place near the center shown in the oval region in figure 1, was the crushing and abrasing fatigue area. The places on both sides of the oval region were the rapid

tearing area. It was easily found from this region that there were many barbs and shear lips formed by tearing nearby the peripheral part. It's generally concluded that the surface layer spalling was formed along the A-A line at the beginning, and then the spalling region extended to both sides of whole ellipse. In each meshing process, the dehiscence region confronted extrusion and wearing once again, and the rapid expansion of crack resulted in spalling after several repeated cycles.

Fig.1. Fractured conical shaped gear and its fissuring

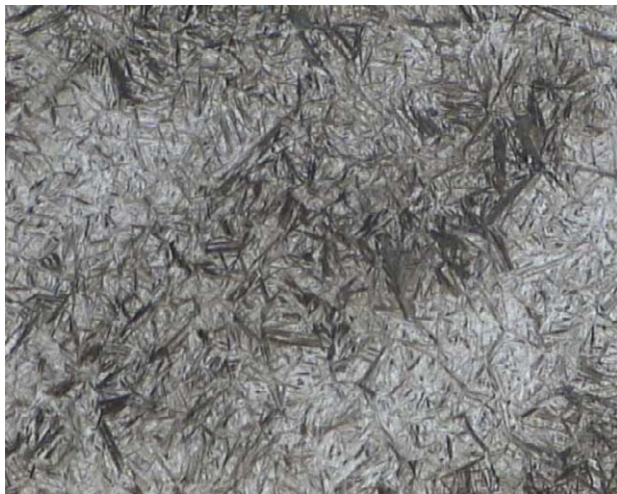
Fig.2. Metallographic (carburized layer) structure of the surface layer ( $\times 200$ )

Metallographic structure analysis was carried out for the samples from the adjacent spalling area. Coarse acicular martensite was found at the surface of gear tooth (carburized layer) (figure 2). The core structure was lath martensite (figure 3). Compared with the conventional heat treated structure of similar gear, the metallographic structure of the gear tooth with surface spalling was normal. However, laths and needles of martensite were obviously coarse. The

original grain boundary could be clearly observed at the lath martensite zone, which suggested that the heating temperature of gear quenching was too high.

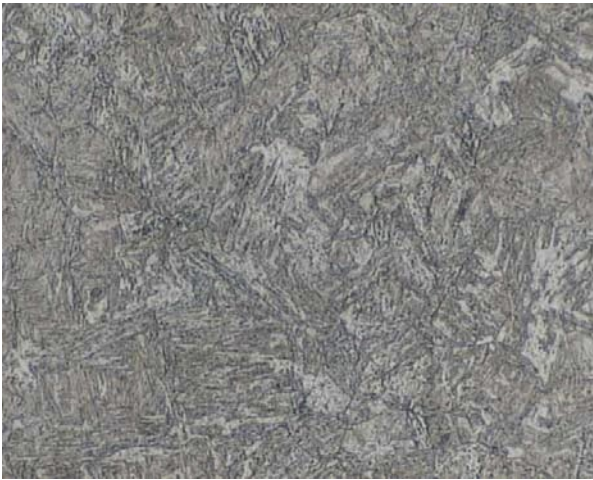
Fig.3. Metallographic structure(interior) of the gear tooth ( $\times 500$ )

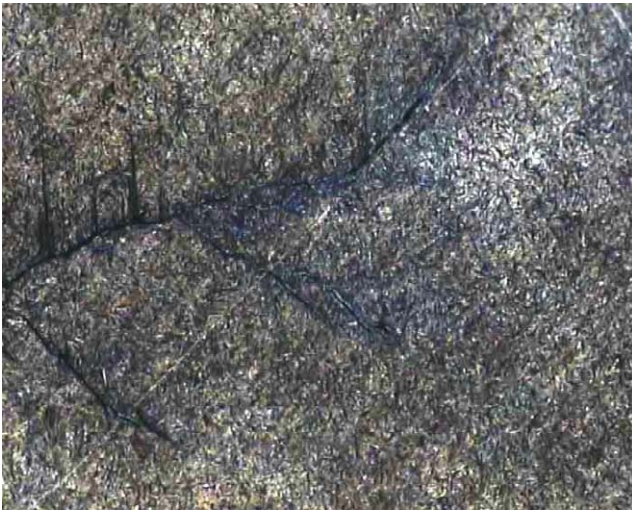
Fig.4. Small cracks (secondary cracks) on the gear tooth surface layer ( $\times 100$ )

Besides the large crack, as shown in figure 1, it was found that there were small cracks (secondary cracks) around the surface of gear tooth, as shown in figure 4. After analysis, at both sides of the crack on the surface layer (carburized layer) were coarse acicular martensite. The structure morpholog, shown in figure 5, was the same as surface layer in figure 2. The metallographic structure at both sides of large cracks near the core was lath martensite. Structure morphology was the same as that in the core of gear tooth in figure 3, which was shown in figure 6.

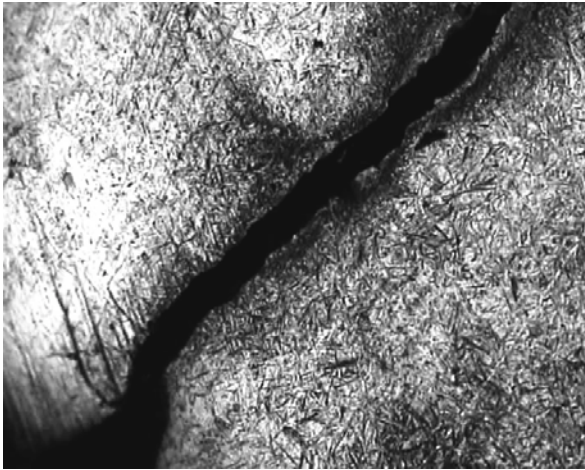
Fig.5. Acicular martensite at both sides of crack on the surface layer ( $\times 100$ )

(2) Microhardness values at both sides of the near surface layer were Hv200 820 at the edge of crack, Hv200 980 at the range within 200  $\mu$ m far from the crack, Hv200 773 at the other places, respectively, with loading force of 200kg and loading time of 15s (figure 5).

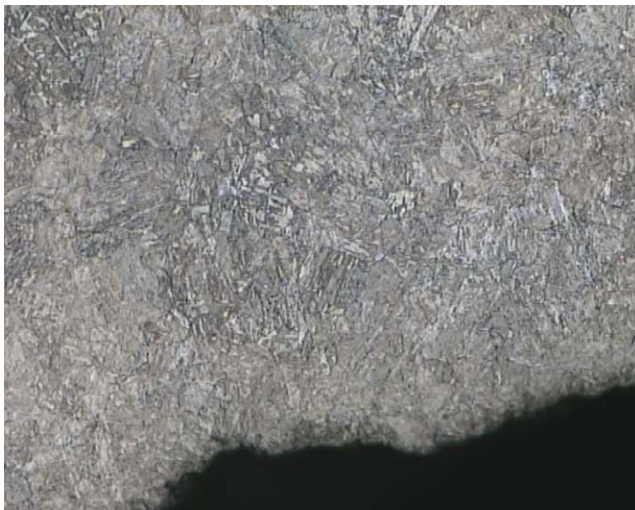
Fig.6. Metallographic structure on one side of big crack (core)( $\times 200$ )

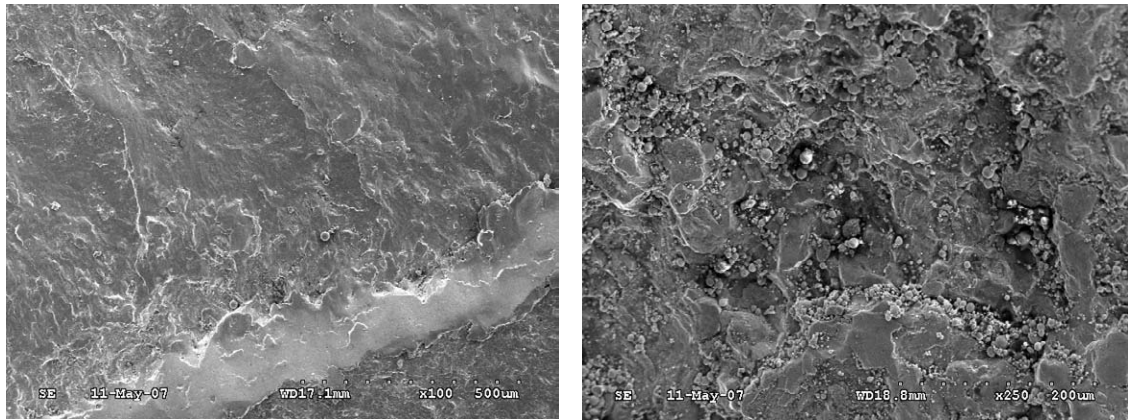
Fracture morphology was analysis by SEM electron microscopy, as shown in figure 7. It could be seen that the fracture had river-like pattern with cleavage fracture characteristics, mostly were transgranular fracture. It could be observed by electron microscopy that spalling face formed plastic deformation due to the two cracking faces squeezed with each other. Cracked grain faces had been planished during the cracking process, which indicated that the cracking faces had experienced the extrusion and wearing for a longer time.

Fig.7. SEM photograph of fracture

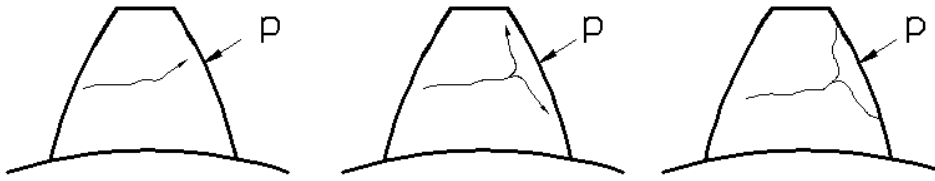
When the crack expanded to the carburizing layer which has very high hardness, the stress was parallel to the tooth surface and almost vertical to the crack at the transition part, i.e. area with the biggest contact stress. Hence, the crack changed the expansion direction and expanded along the transition interface between carburized layer and the matrix, as shown in figure 1. Two cracking faces crushed continuously, which could cause compressive fatigue, so the cracks continued expanding and the crack propagation took place when it expanded to a certain size until the surface peeled off bulk. The process of cracking spalling on the gear tooth was shown in figure 8.

Fig.8. Schematic representation for crack propagation, diversion and spalling
